M/047/002

ANNUAL REPORT OF MINING OPERATIONS

TO: Minerals File  
SUBJECT: Site Inspection, Geokinetics, Seep Ridge Mine, S/047/002, Uintah County, Utah

RE: Site Inspection, Geokinetics, Seep Ridge Mine, M/047/002, Uintah County, Utah

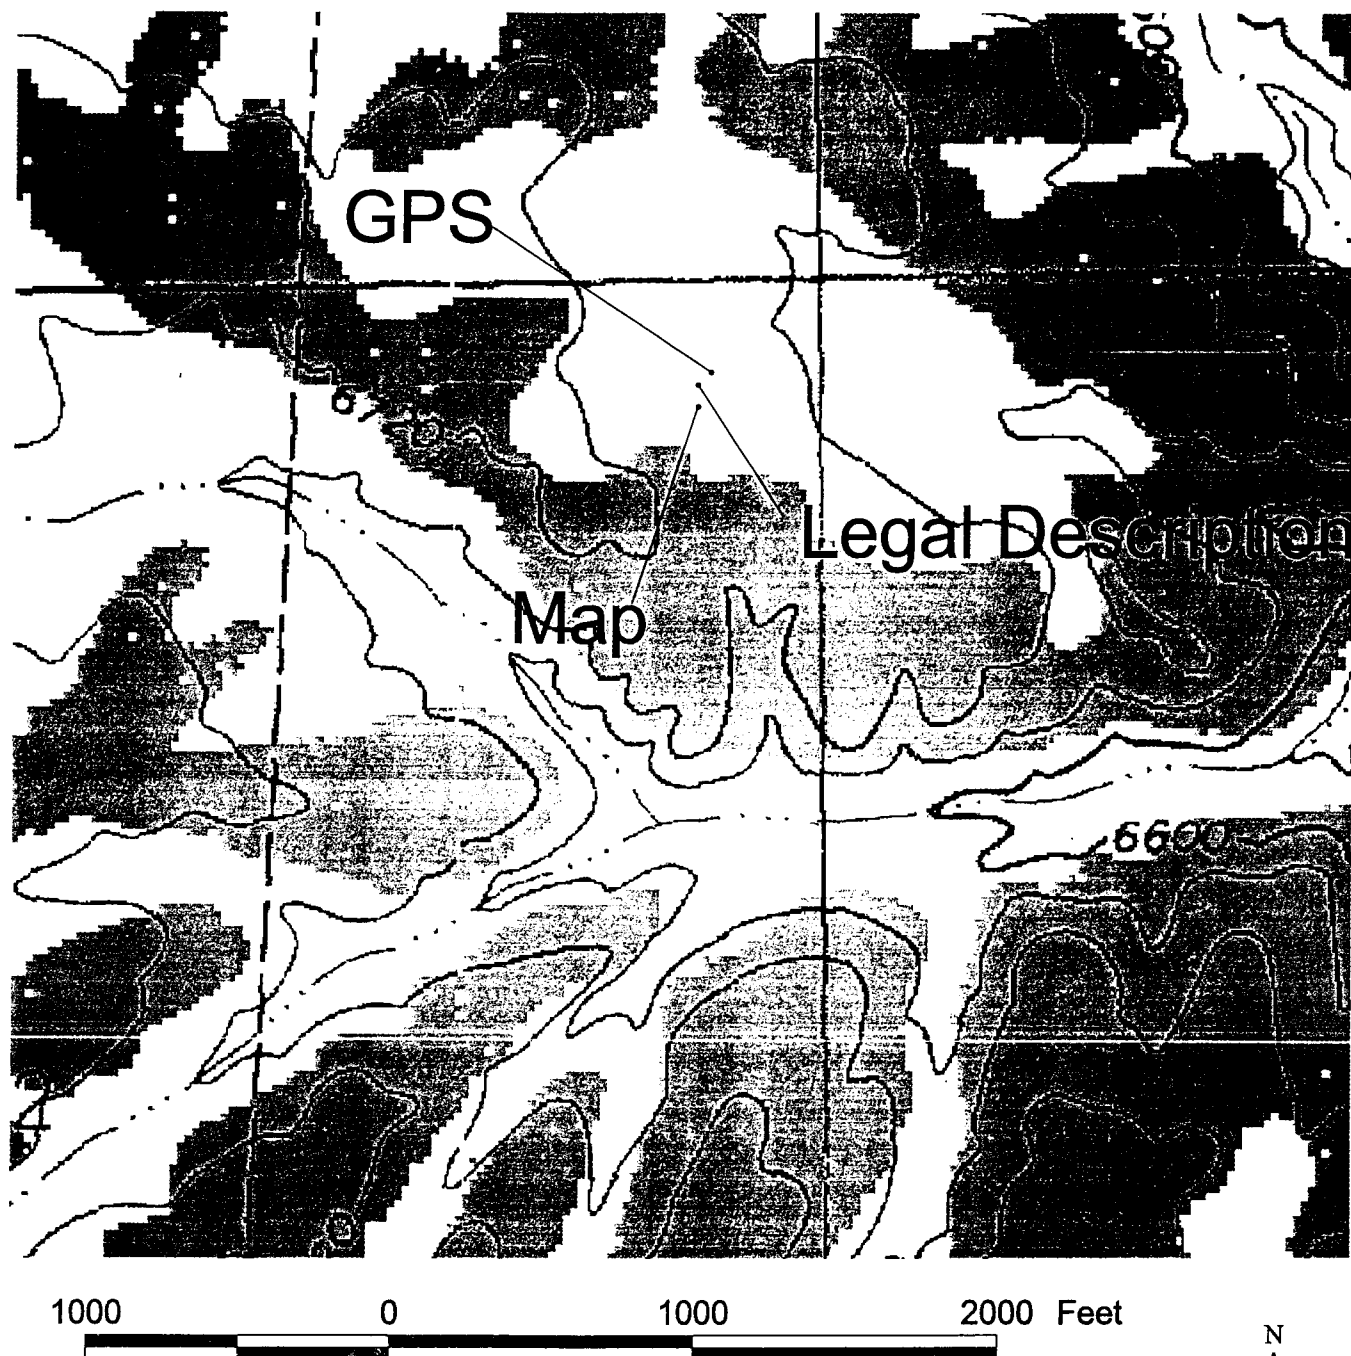
# Seep Ridge Mine M/047/001

During the previous inspection, I took a GPS point at the place where I think the well might be. Attached to this report is a map showing this GPS location. I also plotted the location of the well based on the legal description in the associated water right and according to a map in the mine plan. Although the points appear very close on the map, the point plotted from the legal description and the point based on the mine plan map are actually about 80 feet apart.

Possible locations of a water well in the Seep Ridge Trailer Park area. These locations are based on the water right legal description, measurements from a map in the mine plan, and GPS coordinates of the possible well location. Bates Knolls Quadrangle, Section 2, Township 14 South, Range 22 East, SLBM.

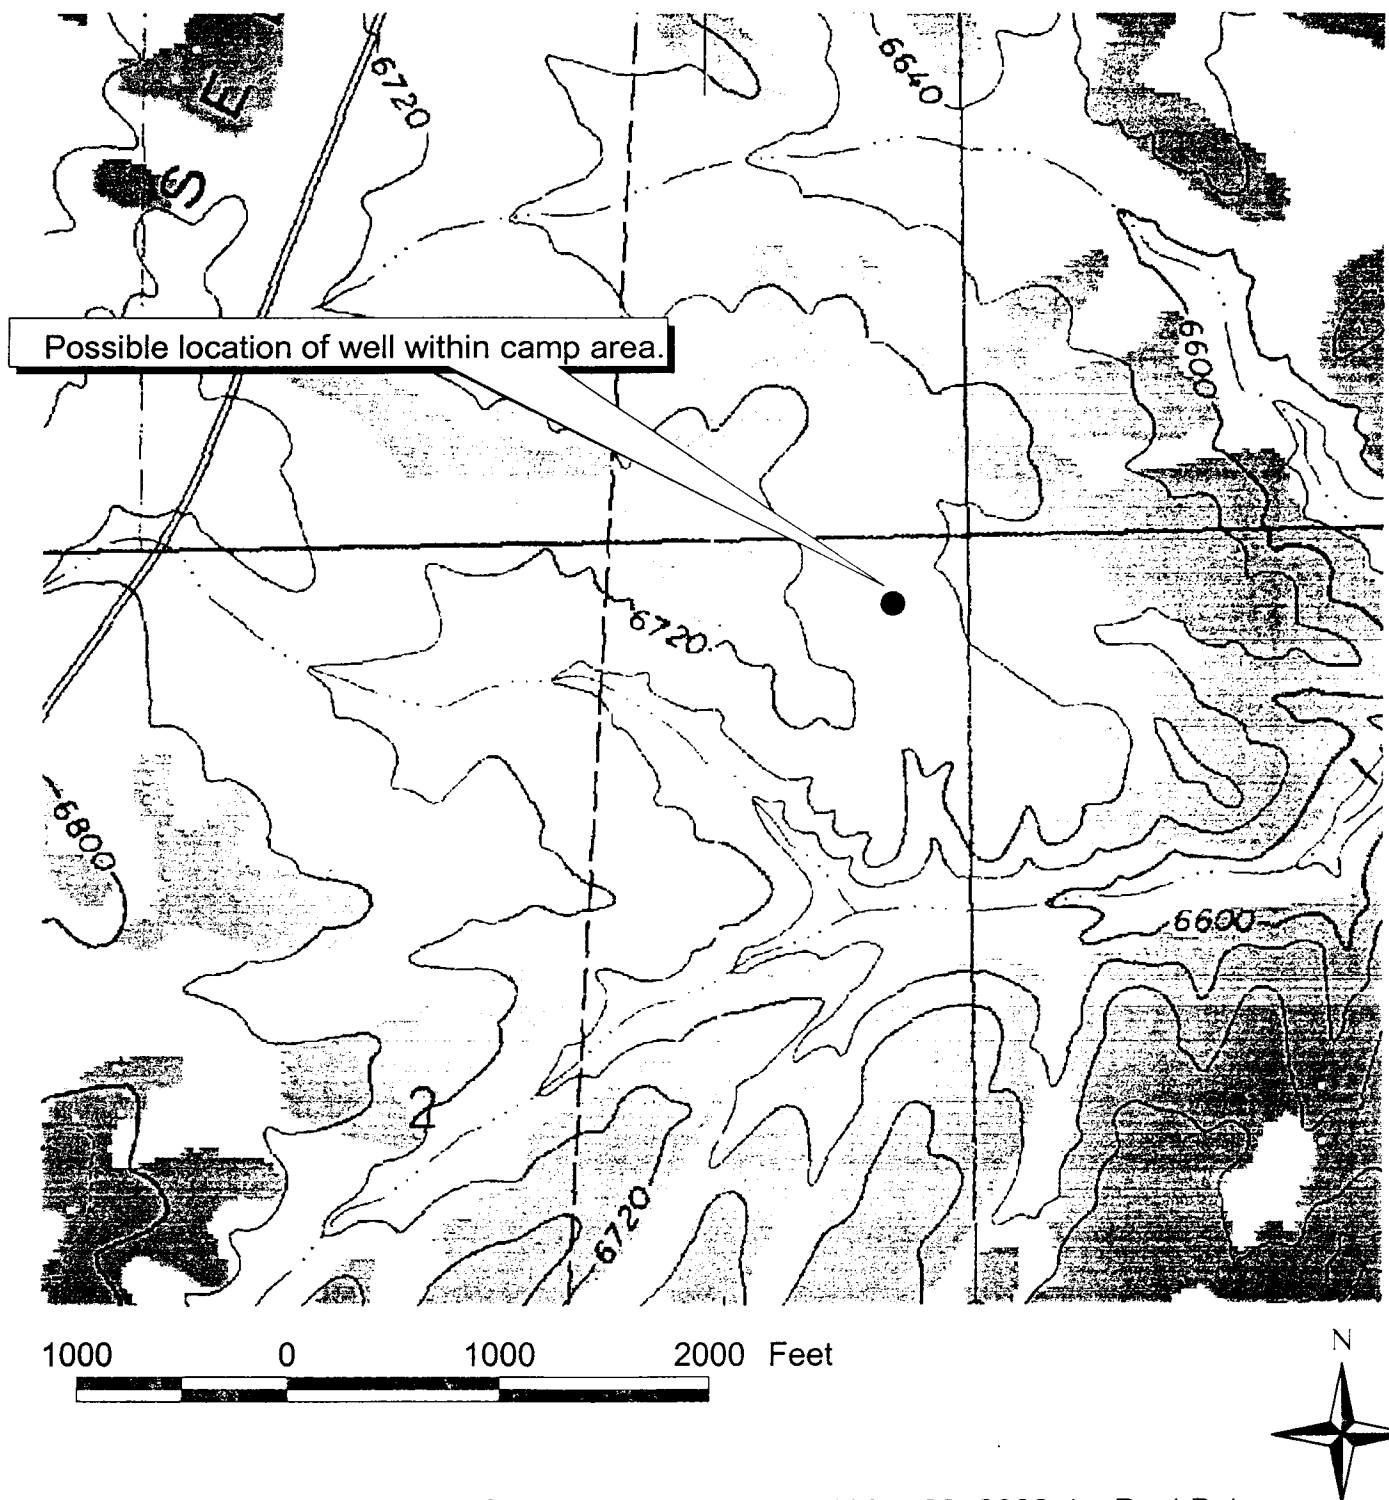
# Seep Ridge Mine S/047/002

Map prepared May 27, 2003, from GPS data gathered May 23, 2003, by Paul Baker.  
Bates Knolls Quadrangle, Section 2, Township 14 South, Range 22 East, SLBM.

Coordinates of the point are 636,134 East, 4,388,246 North.
